UTILIZING TFM/FMC FOR DETECTION OF FLANGE FACE CORROSION

MARK SCHRAMM, *Advanced NDE Services Manager at Pro-Surve Technical Services*

VOLUME 26, ISSUE 3

MAY | JUNE 2020

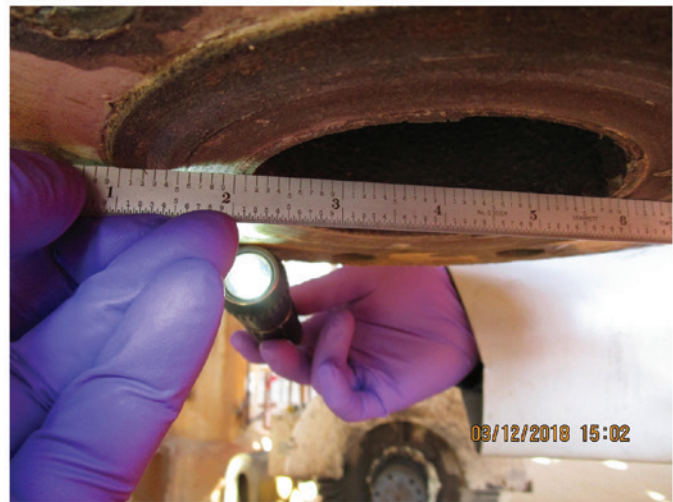
Figure 1. Visual Inspection Using a Straight Edge

Visual inspection is an effective way to detect HF acid corrosion, but it is time consuming and costly (both in labor to open, clean, and inspect as well as to replace gaskets) and must be performed while the equipment is out of service. This results in lost revenue and high labor costs due to the extended shifts that are typical of shutdowns. Since HF acid corrosion is typically found only in a small percentage of flanges in HF acid service, it would seem that many flanges don't need to be opened at all because there is

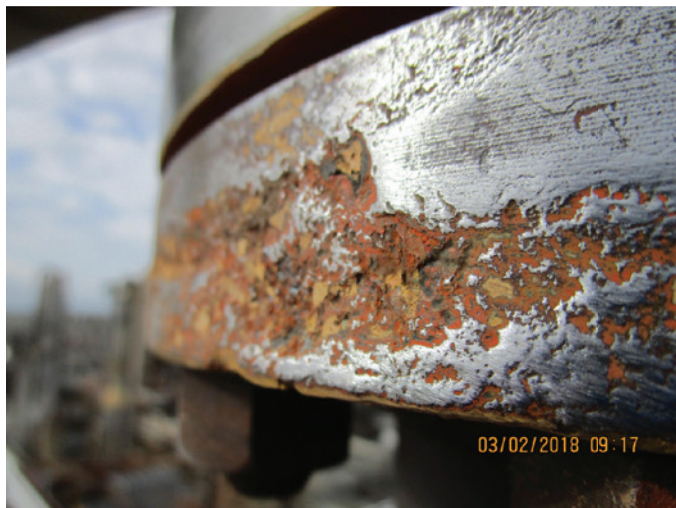
Figure 2. Rough Flange Surface

Many factors can affect the quality of the data and create signal loss because a consistent contact with the probe face is lost:

- a rough outer diameter flange surface (**Figure 2**),
- flange ODs with rounded edges (**Figure 3**), or
- coatings with rough or uneven thicknesses.

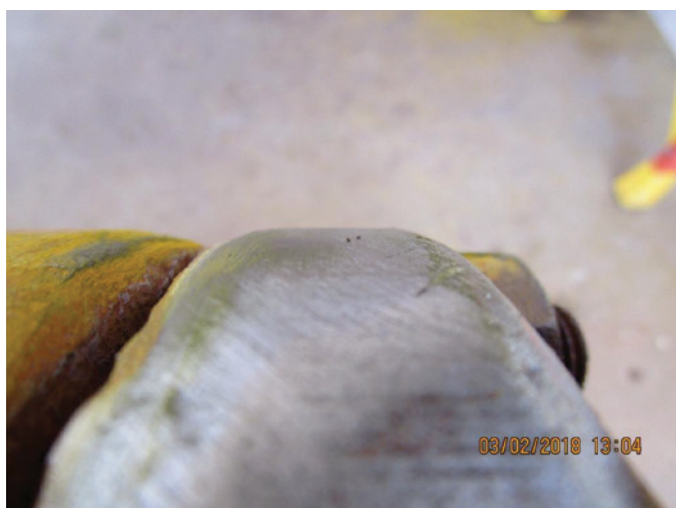
Figure 3. Rounded (Not Flat) Surface
